SERVICE BULLETIN

AMERICAN HONDA MOTOR CO., INC. MOTORCYCLE SERVICE DEPARTMENT

PARKING ANGLE AFFECTS ENGINE LUBRICATION

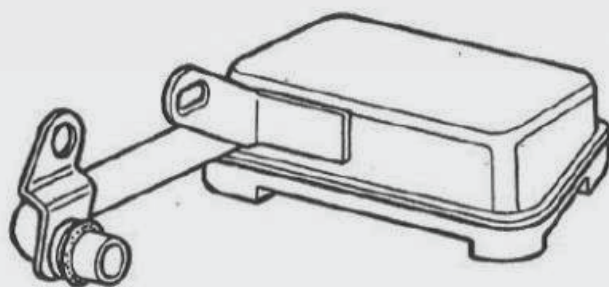
OLD OIL SUMP FILTER ASSEMBLY
H/C 36392, P/N 15421-369-000
H/C 43009, P/N 15421-369-010

If the motorcycle is leaned excessively to the left when parked, engine oil in the crankcase will not completely cover the oil sump filter. Running the engine in this position will allow air to enter the lubrication system and may cause upper end damage from lack of lubrication.

The new oil sump filter is available only as a complete assembly and is recommended as a replacement for the filter assembly on earlier engines. Whenever an early engine is disassembled for overhaul or repair, or if parking angle is suspected as a possible cause of lubrication failure, install the new oil sump filter assembly.

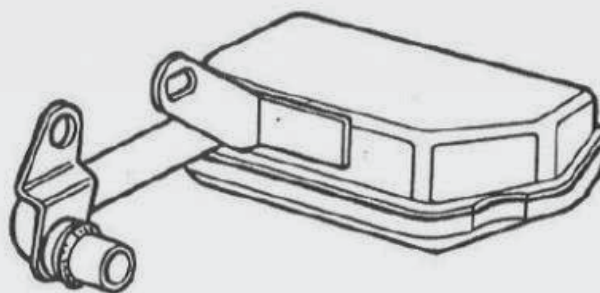
NEW OIL SUMP FILTER ASSEMBLY
H/C 44761, P/N 15421-388-000

A new oil sump filter is available which allows the motorcycle to lean at a greater angle before air enters the lubrication system. The new oil sump filter is standard equipment on the following models:
